AMBROZIK Tomasz<sup>1</sup>  
 ŁAGOWSKI Piotr<sup>1</sup>

## Selected failures of internal combustion engine pistons

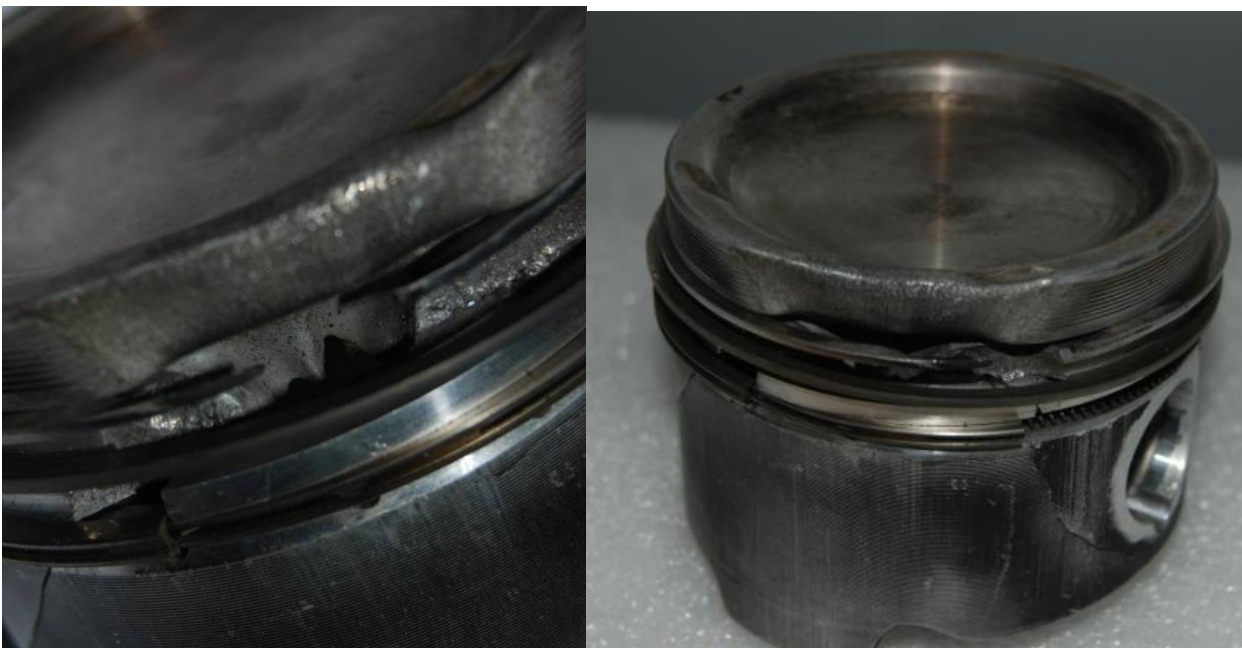
**Fig. 1.** Fusion of the piston head and the ring area

Figure 1 shows a view of a cylinder, on which signs of piston head and ring area fusion in a spark-ignition engine are visible. The fusion of the piston head in spark-ignition engine is caused by a hot-bulb ignition occurring on the pistons, and chiefly on their heads, and in the larger flame extinguishing areas. The hot-bulb ignition occurs due to glowing parts in the combustion chamber,

which have a higher temperature than the autoignition temperature of the air-fuel mixture. As a result of that glowing, the temperature of the piston head rapidly increases. In this process, the temperature attains levels that make the piston material soften and melt. The possible causes of this failure may be due to:

- too low sparking plug heat factor,
- too lean air-fuel mixture, and
- valve damage or leak or an insufficient valve clearance. This causes the valves to close incorrectly. The flowing exhaust gas considerably increases the temperature of the valves, which start glowing. This affects primarily the exhaust valves, as the inlet valves are cooled by the inflowing fresh charge,

- glowing piston head, cylinder head, valve and sparking plug burning residues,
- fuel with an inadequate, too low octane number. The fuel quality must correspond to the engine compression ratio, which means that the octane number must meet the octane requirements of the engine for all operation conditions,

- petrol contamination, e.g. with diesel oil,
- a large amount of oil in the combustion chamber, which may result in a fast oil flow onto the piston rings,

- high engine temperature, which can be caused by inadequate engine chamber ventilation, and overheating.

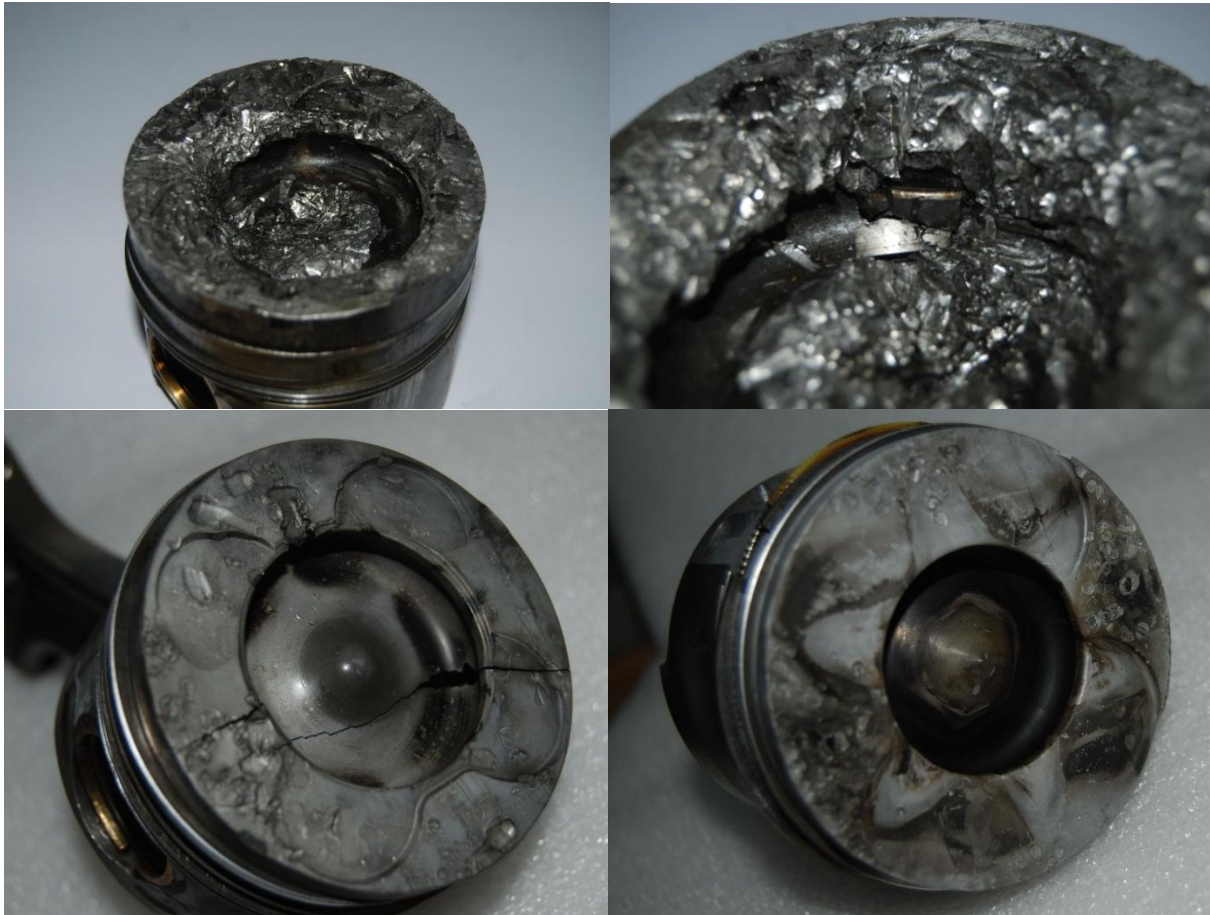
**Fig. 2.** Mechanical piston damage

Figure 2 illustrates the mechanical damage to a piston. During engine operation, a valve or another foreign part fell into the cylinder, causing a piston failure. Mechanical piston damage may occur due to a foreign body entering the cylinder, which has passed through the air filter or got there during repair or maintenance work. Failures due to this cause depend on the size of the part that has entered the cylinder, and its material. It should be noted that, as practice shows, a foreign part that enters one cylinder may, via the inlet or exhaust manifold, get to the other cylinders; so, due to the entrance of one part, failures might occur in many different cylinders. If the size of a foreign body entering the combustion chamber is greater than the minimum distance between the piston head and the valves, then, in addition to the damage of the piston, a valve bending or even valve guide breaking may also occur.

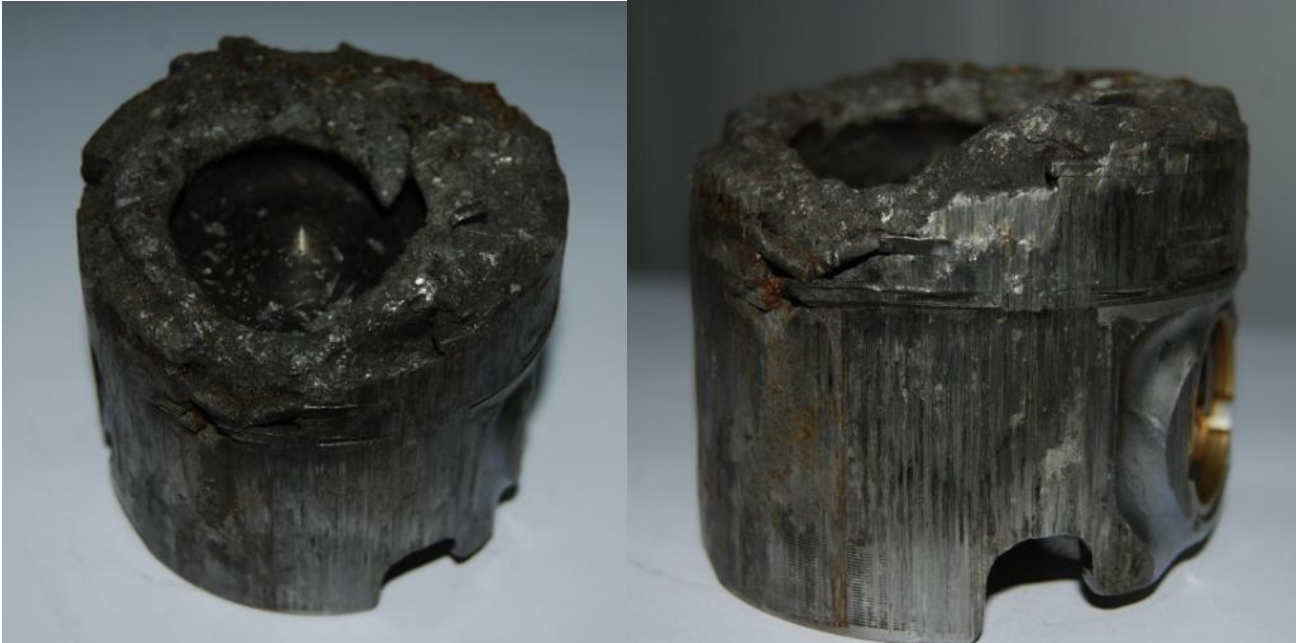
**Fig. 3.** Fusion of the piston head and the ring area

Figure 3 illustrates a piston head fusion. The piston head and crown area has been totally damaged. The upper piston part has been melted down as far as to the rings. The melted material on the piston skirt has caused damage and signs of abrasion. An engine overloading occurs as a result of too large an amount of fuel supplied to the cylinder, and consequently the amount of heat exceeding the quantity assumed by the designer, based of which both the strength of the engine's parts and the efficiency of the cooling and lubricating systems have been selected. The increase in the quantity of heat taken by the piston head may be the result of too large a fuel dose injected to the combustion chamber in a self-ignition engine or the occurrence of detonation combustion in a spark-ignition engine. It can also be caused by an excessive supercharging pressure. With an excessive dose of fuel injected to the cylinder or with a faulty atomizer, a fusion of the upper piston part might occur, as shown in Figure 3. So large extent of piston damage has occurred not only as a result of the excessive amount of heat released in the cylinder, but also due to the reduction of the amount of heat transferred to the cylinder wall, caused by immobilizing the piston rings by the material brought in from the piston crown.

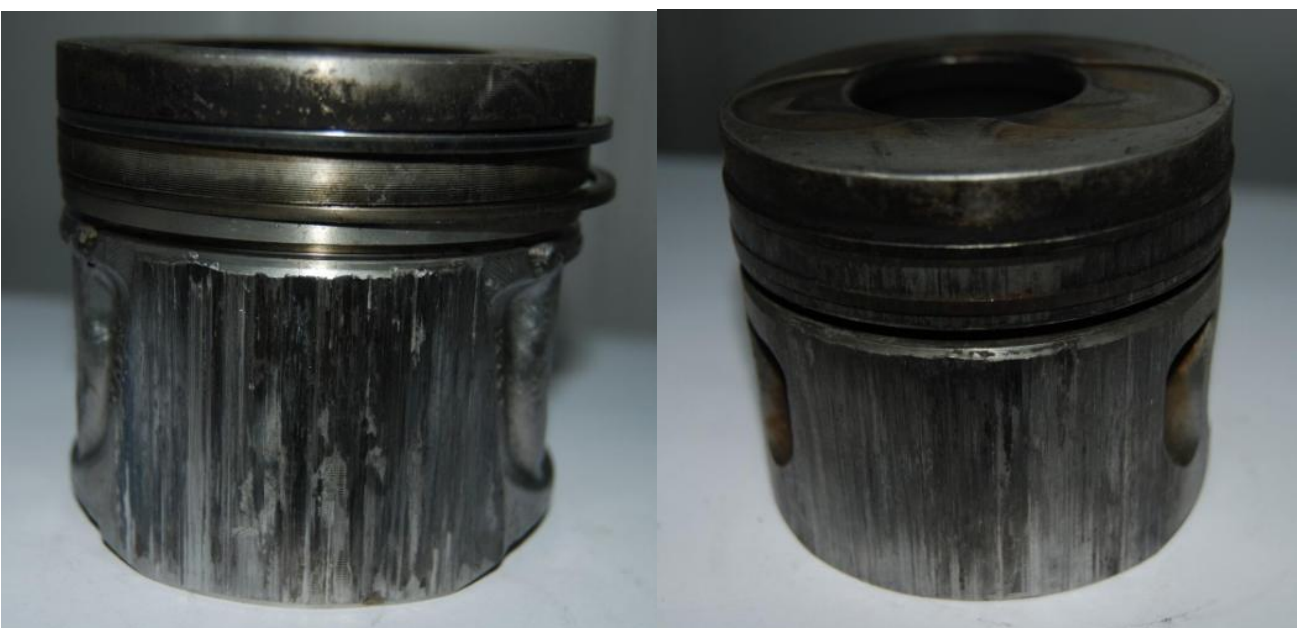
**Fig. 4.** A piston skirt seizure

Figure 4 illustrates a piston skirt seizure. The piston skirt has been almost completely seized. The surface of the abrasion spots has a dark colouring, is rough and heavily over-ground. The ring area is slightly damaged due to the worn piston material that has been rubbed out upwards. The heavy overheating of the whole engine is caused by the deterioration of the cylinder lubrication process. This has resulted in characteristic abrasion signs, caused by the insufficient lubrication with surface over-grinding. The absence of abrasions on the piston crown and the damage located on the piston skirt preclude overloads caused by an incorrect combustion process. Likely causes of this failure include:

- engine overheating due to a malfunction of the cooling system (cooling medium shortage, fouling, a faulty water pump, a broken thermostat, a broken V-belt, an inadequate or incorrect system responsible for the cooling system),
- in air-cooled engines: overheating due to deposits and fouling inside the cylinder, a broken cooler or a malfunction of the air cooling ventilation system.

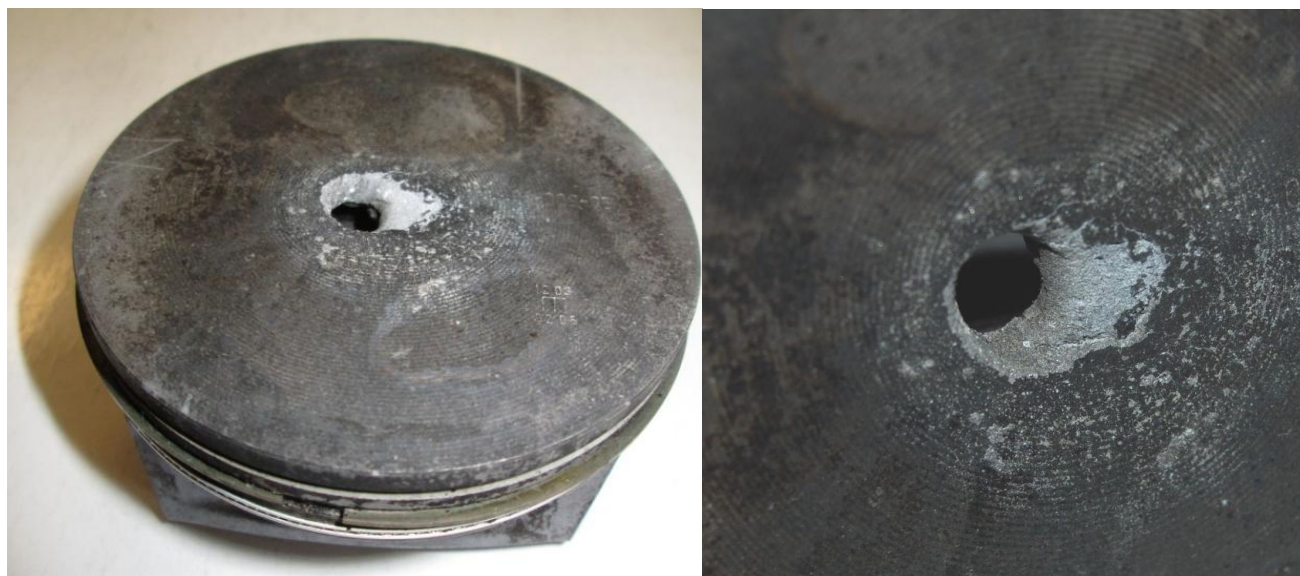
**Fig. 6.** A hole in the piston head in a spark-ignition engine is caused by a premature ignition or a hot-bulb ignition

The ignition advance in a spark-ignition engine may be caused by the improper adjustment of the advance angle or be due to a failure of the timer-distributor or a failure of the electronic ignition spark timing system. A delay in ignition relative to the moment specified as optimal by the manufacturer is not dangerous to the engine. What is very dangerous, however, is an excessive ignition advance, which will result in an increase in the maximum combustion pressure, an increase in the pressure increase rate during the combustion process, and a rapid temperature increase in the cylinder. This will generate a considerable amount of heat which will be taken by the piston head. Apart from the above-mentioned causes of the incorrect ignition advance angle, a premature ignition can be caused

by glowing particles of carbon deposit built up on the combustion chamber walls or a sparking plug with an inadequate heat factor. The hot-bulb ignition may also be induced by a damaged insulator of the central sparking plug electrode. As the combustion of the air-fuel mixture takes place simultaneously within the entire combustion chamber volume, therefore temperature differences occur. The highest temperatures occur in those combustion chamber locations, where the combustion process starts, that is in the vicinity of the sparking plug or the hot-bulb ignition occurrence place. This also causes differences in piston head temperature, with the highest temperatures occurring in those locations that are situated closest to the ignition initiation location. In the piston head spots that are in contact with the air-fuel mixture at the highest temperature, the greatest increase in piston head material temperature will occur. The strength of the piston material decreases with increasing temperature. At the moment, when the strength of the piston material becomes lower than the medium pressure prevailing in the combustion chamber, its failure will occur in the form of a fairly regular hole blown out in the piston head.
